Investigation and solution of bump-like killer defects

YE-O-135

Hong Xiao, Jack Jau, *Huang Kai-Ping, *Tan Yong Seng, and **Patrick Koh Guan Hock
Hermes Microvision, Inc., 1762 Automation Parkway, San Jose, California 95131, USA

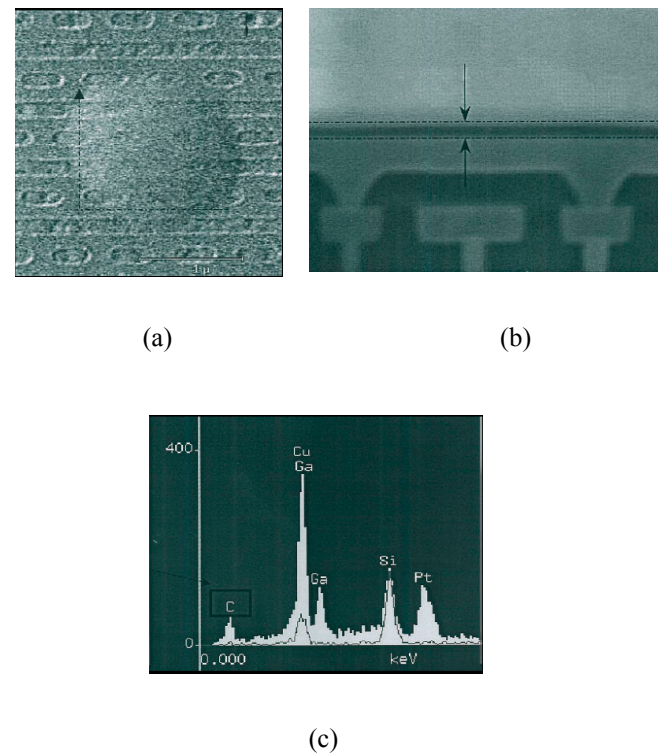
Bump-like defects were observed by dark field (DF) optical inspection system at silicon nitride (SiN) cap layer after CuCMP, as shown in Figure 1a. Cross-section SEM image in Figure 1b showed the bump was underneath the SiN cap layer. Energy dispersive spectrometry (EDS or EDX) results shown in Figure 1c indicated the bump defects mainly consisted with Cu, which is conductive and could cause electrical short. Strong correlation between EBI die sampling map and DF bump defect map was observed, as shown in Figure 2a and Figure 2b. Figure 2c is the within die care area of eScan®300 inspection and Figure 2d shows the DF within die defect distribution, which also strongly correlated with each other.

Figure 1. (a) Review SEM image of bump defect on nitride cap of CuCMP, (b) cross-section SEM image of the bump defect, and (c) EDX data of the Cu CMP bump,

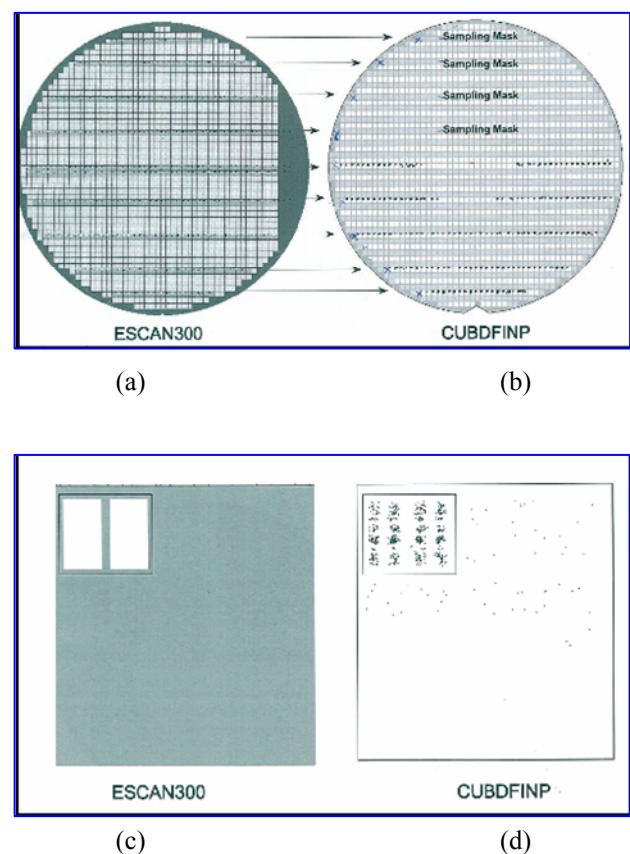
Figure 2. (a) EBI die sample map, (b) DF defect map, (c) EBI care area within a die, and (d) DF defect distribution within a die.

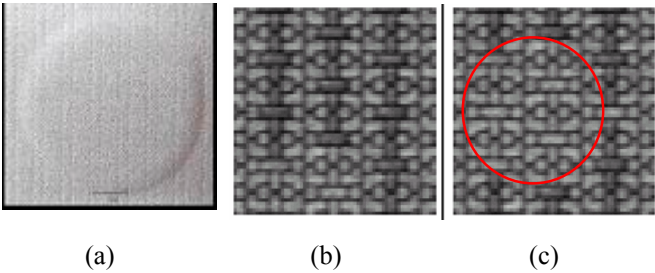
Similarly, bump defects were also captured by DF inspection system at SiN cap layer after WCMP. WCMP bump defect review SEM image was shown in Figure 3a. EBI captured bump-induced electrical short at metal 1 (M1) CMP as round-shaped cluster bright VC (BVC) defects, indicated the WCMP bumps were also electrically conductive. Figure 3b is the EBI reference image of the Figure 3c is the EBI defect patch image. Figure 4a is review SEM image of bump defect captured by DF inspection after de-ionized (DI) water clean of a WCMP wafer that was just inspected by an EBI system. Figure 4b

Figure 3. (a) SEM review image of bump defect on nitride cap after WCMP, (b) reference image of M1 (c) cluster BVC detect patch image of M1.

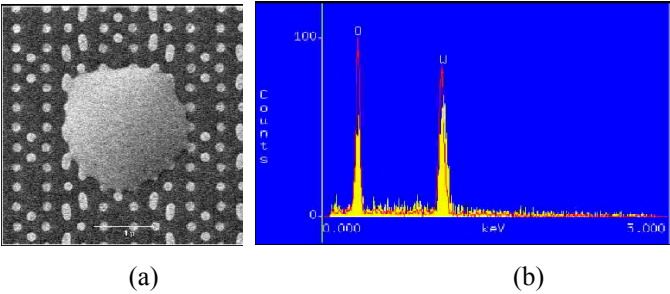
showed the EDX data of the defect in Figure 4a, which indicated that the bump formed after WCMP EBI mainly consists with W, similar to the bump formed after CuCMP that mainly consisted with Cu.

Figure 4. (a) Review SEM image of a bump defect of WCMP, (b) EDX data of WCMP bump.

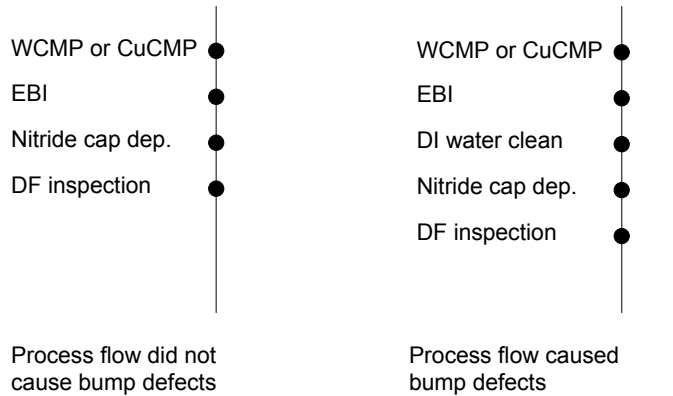
Because bump defects are yield killers, we did thorough investigations to find the root cause. Since we did not observe bump defects in previous lots, we suspected the process change was the root cause. We checked the process flow and found that a DI water clean step was added between EBI and SiN cap layer deposition, as shown in Figure 5. The original purpose of the DI water clean was to remove possible particles before the SiN cap layer deposition. It gave us a hint that it was likely the combined effects of EBI and DI water clean caused the bump defects. Several theories were brainstormed and eventually we agreed on with the micro-plating model, as illustrated in Figure 6.

Figure 5. Process flows that caused bump defects and did not cause bump defects

We found that the EBI alone would not create yield killing bump defects. The conducting bump defects were form only when DI water clean is performed right after EBI of WCMP wafer or CuCMP wafer. Defect formation mechanism was proposed and experiment results collected in this study strongly support our explanation. To avoid yield loss due the bump defects, one should perform DI wafer clean before EBI, not after it.

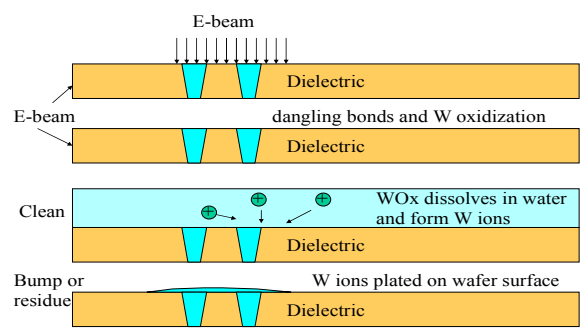
When energetic electron beam (e-beam) of EBI system scanned across the sample surface with both metal and dielectric, such as WCMP wafer or CuCMP wafer, it would breakdown the chemical bonds on metal surface, which made the metal easier to be oxidized when exposed to air and moisture. During DI water clean, excessive metal oxide, such as tungsten oxide formed due to e-beam bombardment of W surface dissolved in DI water as positive W^+ ions, which quickly deposited on the dielectric surface to form bump-like defects and caused electrical short between W plugs. DI water clean right after CuCMP EBI can also from bump-like defect caused by deposition of Cu^{++} ions on the wafer surface.

Figure 6. Illustration of WCMP bump formation.

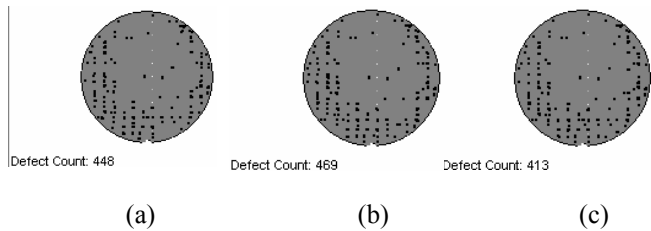
We used an EBI system, eScan®300, for the first two experiments with two WCMP wafers. Figure 7 illustrated the experiment steps of Experiment 1 with WCMP wafer #1 and the results shown in Figure 8. The purpose of the experiment was to determine whether WCMP EBI alone could generate bump defects. The first DF inspection (DF1) took after WCMP captured 448 defects, the second DF inspection (DF2) after DI water wafer clean captured 469 defects. The third DF inspection (DF3) after EBI captured 413 defects. None of these defects was bump-like defect. The results showed that EBI alone did not create the bump defects.

Figure 8. DF inspection defect maps of Experiment 1, (a) DF1, (b) DF2 and (c) DF3.

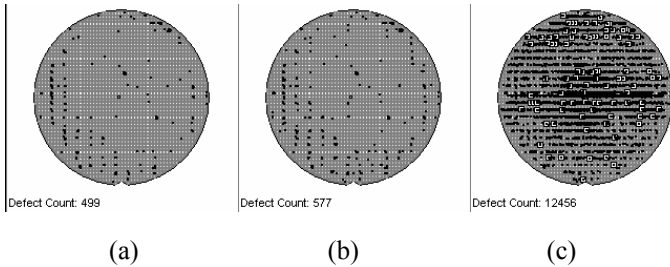
Figure 9 showed the process steps of Experiment 2 with WCMP wafer #2 to determine whether DI water clean after EBI was responsible to the bump-like residues. The results in Figure 10 showed the dramatic increase of defect count, 12456, captured by DF3 after DI water clean, comparing with the defect count of 577 captured by DF2 after EBI. Review SEM image showed most of the defect captured in DF3 were bump-like defects. That support our theory that micro-plating

Figure 10. DF inspection defect maps of Experiment 2, (a) DF1, (b) DF2 and (c) DF3.

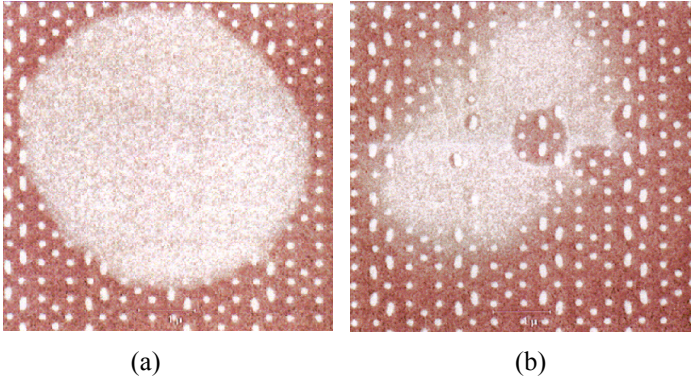
due to by DI water clean immediately followed WCMP EBI formed the bump defects. Figure 11a and 11b are the review SEM images of the bump defects captured by DF3 of Experiment 2 near the wafer center and near the wafer edge, respectively.

Figure 11. Review SEM images of bump-like residue captured by DF3 of Figure10c. (a) Near wafer center and (b) Near the wafer edge.

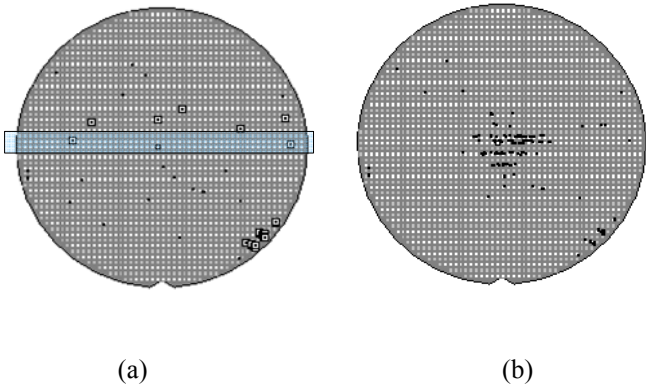
In experiment 3, we used a review SEM system and WCMP wafer #3. Figure 12 showed the process flow of Experiment 3. DF1 before taking review SEM images found 70 defects, as shown in Figure 13a. DF2 after review SEM e-beam scan before DI wafer clean found 76 defects. DF3 found defect count sharply increased to 213 after DI water clean, as shown in Figure 13b. The review SEM images showed in Figure 14 clearly indicated the added defects were bump-like residues. We could see that if one did DI water clean on a WCMP wafer after taking review SEM images, it could generate bump defects. The results of experiments strongly supported the micro-plating model: it was the combination of e-beam scan and DI water clean of metal (W and Cu) CMP wafer that caused the conductive bump defects.

Figure 13. DF inspection defect maps of Experiment 3, (a) DF1 and (b) DF3.

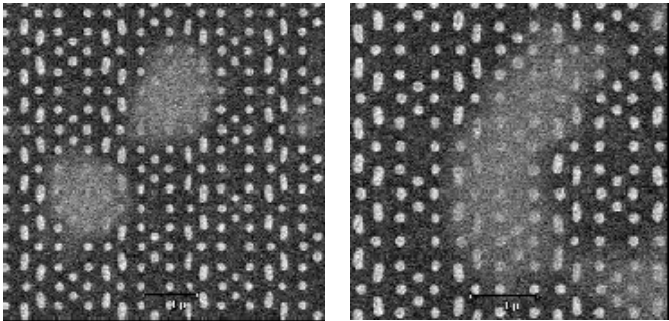
Figure 14. Review SEM image of bump-like residue captured in DF3 of Experiment 3.
