Study of Devices Leakage of 45nm node with Different SRAM Layouts Using an Advanced e-beam Inspection Systems

Hong Xiao, Long (Eric) Ma, Fei Wang, Yan Zhao, and Jack Jau
Hermes Microvision, Inc.

Abstract – In this study, a nickel silicide (NiSi) wafer and a WCMP wafer were used. We captured bright voltage contrast (BVC) defects at N+/P-well on NiSi wafer, we also captured N+/P-well leak/short defects on WCMP wafer as BVC defects in positive mode inspection and dark voltage contrast (DVC) defects in Negative Mode™ inspection. N+/P-well leakage signatures of the two inspection modes of WCMP strongly correlate with each other, which indicate they are the same defects. N+/P-well leakage signature on WCMP wafer also correlate with that on NiSi wafer. With negative mode inspection, we captured P+/N-well leakage on WCMP wafer at two different static random access memory (SRAM) arrays (SRAM1 and SRAM3) as DVC defects. The P+/N-well leakage signature is very different from N+/P-well leakage signature in SRAM3. P+/N-well leakage signature of SRAM1 is also very different from that of SRAM3. This study confirmed our prediction that different SRAM layout will cause different P+/N-well leakage

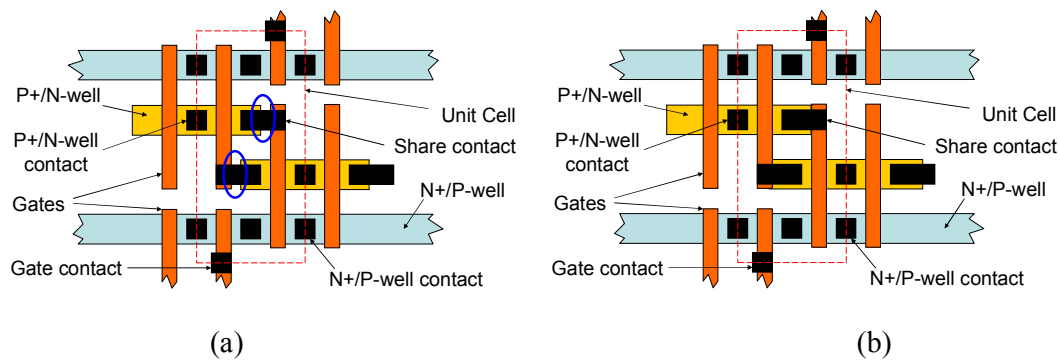
Start from 65 nm technology node, we observed several different leakage mechanisms of P+/N-well of p-channel metal-oxide-semiconductor field effect transistor (pMOSFET or PMOS), such as W spiking caused by over etch [4] and NiSi spiking likely caused by photo-electro-chemistry. [5] For advanced static random access memory (SRAM), over etch induced PMOS leakage is related to its layout. Figure 1a illustrates a layout of SRAM that has high risk of PMOS leakage caused by over etching induced W spiking, because the share contact touched the STI oxide. Figure 1b illustrates the SRAM array that has less such risk. Gate to active area (AA)

Figure 1. (a) Illustration of SRAM layout that has higher risk of overetch-induced PMOS leakage due to STI oxide exposed to the contact etch process. (b) Illustration of SRAM layout that has lower risk.

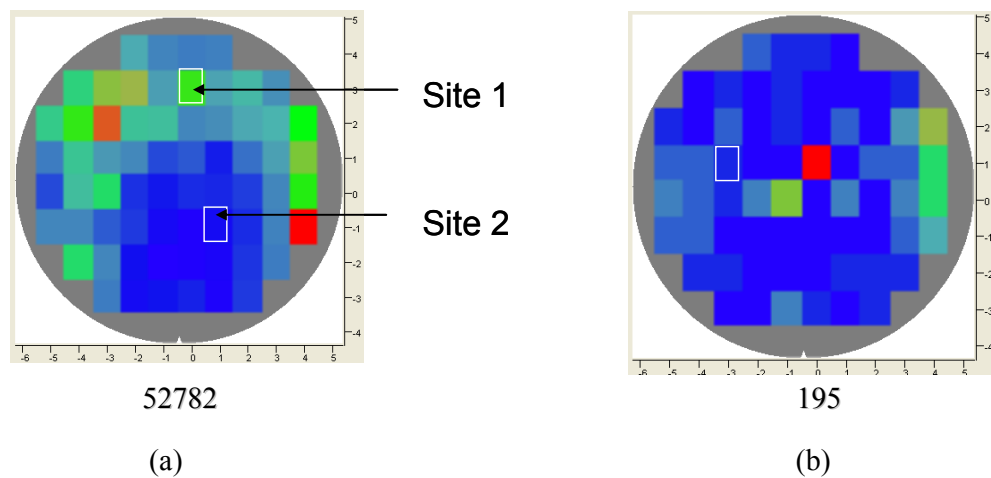
Figure 3. P+/N-well leakage defect maps, FA sites, and total defect numbers of (a) SRAM1, (b) SRAM3. White dies with frame indicate the sites of FA.

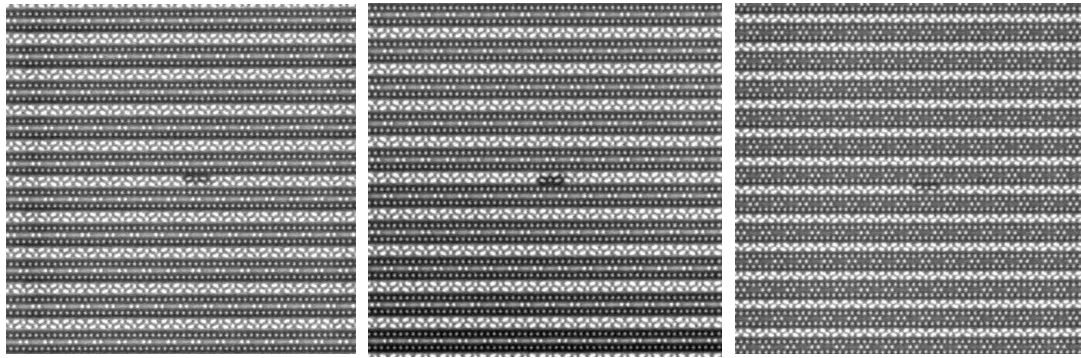
Figure 4. Review images P+/N-well leakage defect. (a) SRAM1 site 1, (b) SRAM1 site 2, and (c) SRAM3.

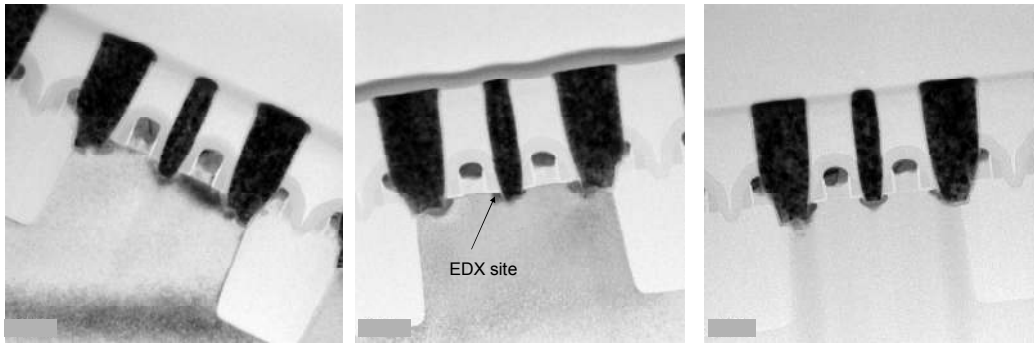
We did the failure analysis (FA) on two sites of SRAM1 and one site of SRAM3. Tunneling electron microscope (TEM) images of defects in Site 1 of SRAM1, Site 2 of SRAM1, and SRAM3 are shown in Figure 5a, 5b, and 5c, respectively. From Figure 5a, we can see that at the Site 1, in the horseshoe of Figure 3a, the P+/N-well leakage is caused by over etching of the share contact, which shorts the P+ source/drain (S/D) junction and the N-well after W plug formation. Figure 5b shows the P+/N-well leakage is caused by NiSi piping underneath the spacer that shorts the (S/D) to the N-well. Figure 5c shows the TEM image of the P+/N-well DVC of SRAM3. We can see that the leakage is also caused by over etch of the share contact. Table 1 shows the energy dispersive X-ray (EDX) spectroscopy data collected from the defect site in Figure 5b, which confirmed the defect is NiSi piping.

Figure 5. TEM images of P+/N-well leakage defects in (a) Site 1 of SRAM1, (b) Site 2 of SRAM1, and (c) SRAM3. Locations of these defects are shown in Figure 4a, 4b and 4c, respectively.

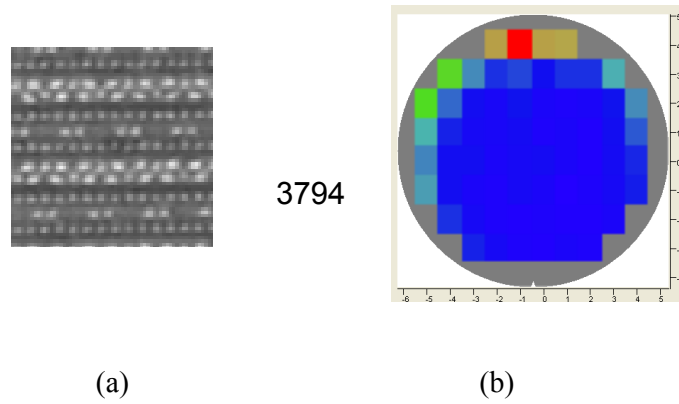
In SRAM1 Negative ModeTM inspection, we have also captured DVC on N+/P-well plugs, which indicate the short of N+ junction to the P-well and P-type substrate. The defect inspection patch image is shown in Figure 6a and defect number and map is shown in Figure 6b. Comparing Figure 3a with Figure 6b, we found that in

SRAM1, P+/N-well leakage (DVC) defect density is much higher than N+/P-well leakage, and their signatures are not the same, indicating different leakage mechanism. As we discussed, P+/N-well leakage in SRAM1 is mainly caused by over etching of the share contact hole along with some NiSi piping, while the N+/P-well leakage is mainly caused by NiSi encroachment and piping, which will be discussed in next section.

Figure 6. Negative ModeTM EBI N+/P-well DVC defects in SRAM1. (a) defect patch image and (b) defect number and map.

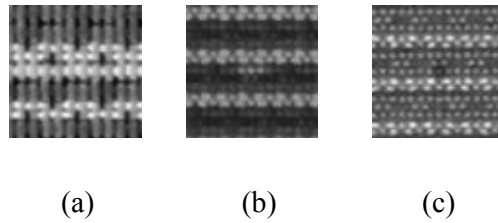
Figure 7. Inspection patch images of N+/P-well leak/short defect in SRAM3. (a) NiSi EBI, (b) WCMP positive mode EBI, and (c) WCMP Negative ModeTM EBI.

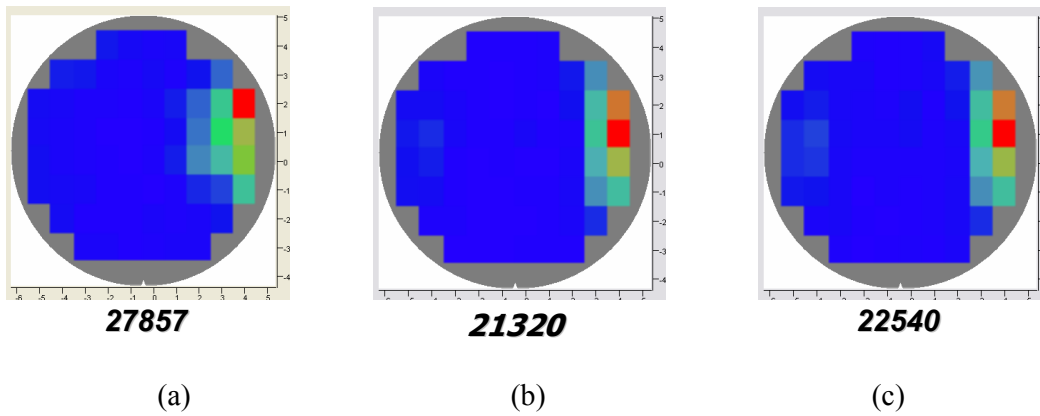
Figure 8. SRAM 3 N+/P-well leak/short defect maps and numbers of (a) NiSi EBI, (b) WCMP positive mode EBI, and (c) WCMP Negative ModeTM EBI.

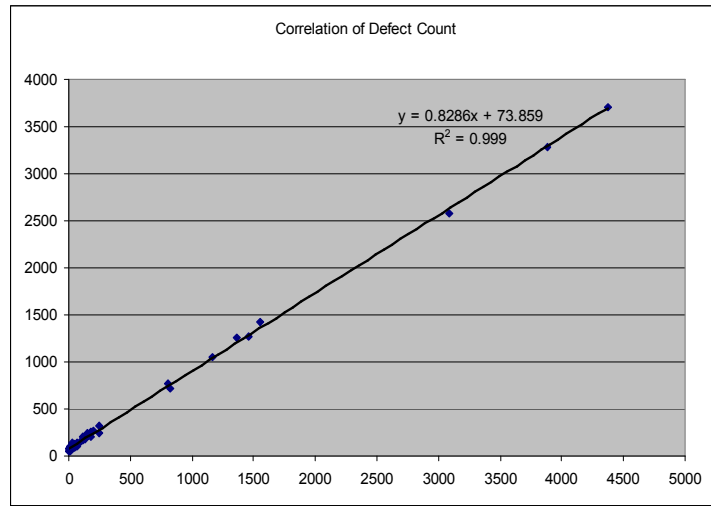
Figure 9. Correlation of N+/P-well leak/short defects per die.

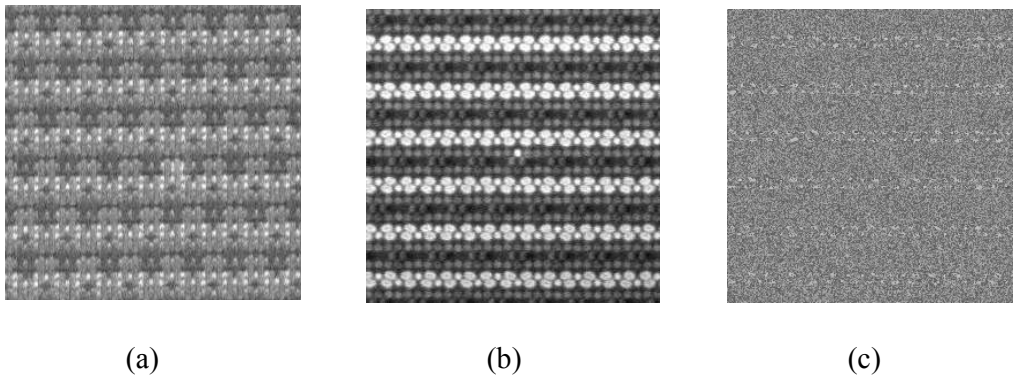
Review images of NiSi N+/P-well BVC defect is shown in Figure 10a. During inspection, because the pass gates were biased positively, the n-channel of the NMOS were turned on, therefore, one N+/P-well leakage could cause surface potential drop of whole row of N+ junction with the common P-well and caused BVC of the row in the inspection defect patch image, as shown in Figure 7a. During review, the current density increased significantly, and charges have trouble to leak to ground through a tandem of turned on n-channels. Therefore, only leaked N+ junction and few junctions right next to it show BVC, as shown in Figure 10a. Figure 10b is the positive mode review image of N+/P-well leak/short captured as BVC by positive mode WCMP EBI. Figure 10c is the Negative ModeTM review image of the same defect which shows out as DVC.

It was the first time we captured N+/P-well DVC defects in WCMP Negative ModeTM EBI. Because N+/P-well junction would turn on when surface charged negatively to $\sim -0.7V$, the W plugs contact N+/P-well in Negative ModeTM EBI are normally surrounded by a dark ring and it is difficult to capture leakage defect, which theoretically could make the ring a little darker. When N+ junction shorts to the ground and plugs surface potential changes from around $-0.7V$ to $0V$, N+/P-well plugs will show as DVC defects in Negative ModeTM EBI. Thus we can confidently predict the NMOS leakage defect shown in Figure 10b and 10c is N+ junction short to P-well and p-type substrate.

Figure 10. Defect review images of SRAM3 N+/P-well leak/short. (a) NiSi BVC, (b) WCMP positive mode BVC, (c) Negative ModeTM DVC of the defect shown in (b).

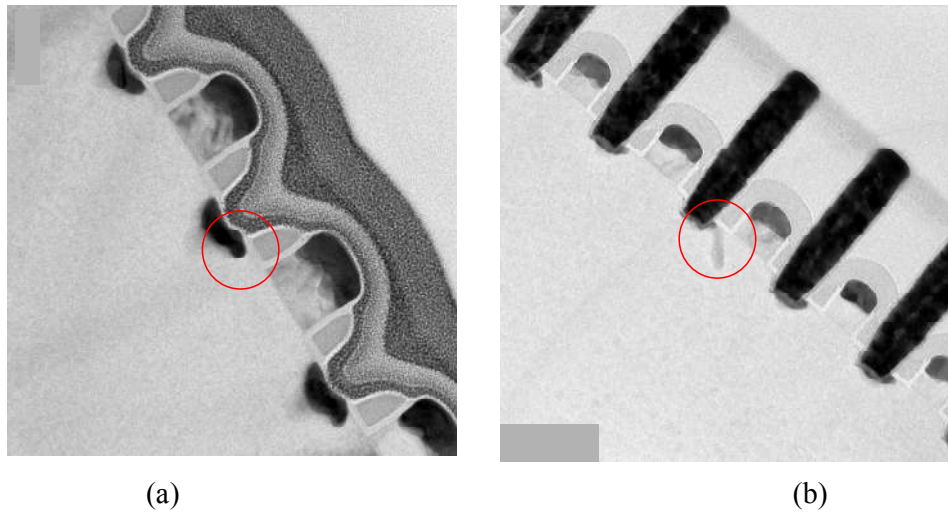
We performed N+/P-well defect FA on both NiSi BVC and WCMP positive mode BVC. Figure 11a is the TEM image of defect shown in Figure 10a. It clearly shows the NiSi encroachment underneath the spacer that causes the leakage. Figure 11b is the defect shown in Figure 10b, which shows the NiSi piping due to dislocation that caused N+ junction short to the P-well and p-type substrate. From upper left corner of Figure 10b, we can also see NiSi encroachment underneath spacer, similar to the ones in Figure 11a. In Figure 10b, that plug shows a weak BVC while the plug with NiSi piping shows a strong BVC.

Figure 11. (a) TEM image of NiSi BVC defect shown in Figure 10a. (b) TEM image of WCMP positive mode BVC defect shown in Figure 10b.
