Study of Devices Leakage of 45nm node with Different SRAM Layouts Using an Advanced e-beam Inspection Systems

Hong Xiao, Long (Eric) Ma, Fei Wang, Yan Zhao, and Jack Jau
Hermes Microvision, Inc.

Abstract – In this study, a nickel silicide (NiSi) wafer and a WCMP wafer were used. We captured bright voltage contrast (BVC) defects at N+/P-well on NiSi wafer, we also captured N+/P-well leak/short defects on WCMP wafer as BVC defects in positive mode inspection and dark voltage contrast (DVC) defects in Negative Mode™ inspection. N+/P-well leakage signatures of the two inspection modes of WCMP strongly correlate with each other, which indicate they are the same defects. N+/P-well leakage signature on WCMP wafer also correlate with that on NiSi wafer. With negative mode inspection, we captured P+/N-well leakage on WCMP wafer at two different static random access memory (SRAM) arrays (SRAM1 and SRAM3) as DVC defects. The P+/N-well leakage signature is very different from N+/P-well leakage signature in SRAM3. P+/N-well leakage signature of SRAM1 is also very different from that of SRAM3. This study confirmed our prediction that different SRAM layout will cause different P+/N-well leakage

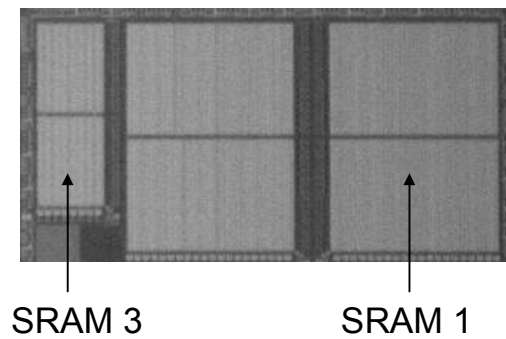
In this study, we used eScanLite® of Hermes Microvision, Inc. (HMI) to run Negative ModeTM inspections of two SRAM arrays, SRAM1 and SRAM3 in a 45nm WCMP wafer. Figure 2 is the optical image of the two SRAM arrays. The EBI conditions are landing energy (LE) 3000eV, beam current 100nA, and pixel size 40nm. We have successfully captured P+/N-well leakage as dark voltage contrast (DVC) defects. The DVC defect map and total defect number of SRAM1 and SRAM3 are shown in Figure 3a and 3b, respectively. The defect maps show that SRAM1 P+/N-well leakage has a strong horseshoe style signature, while SRAM3 P+/N-well is pretty random with a little right side (notch down orientation) signature. The defect density of SRAM1 is much higher than that of SRAM3; the ratio of average defect density of SRAM1 to SRAM3 is about 360:1. Figure 4a, 4b and 4c are the review images of the P+/N-well DVC defects at SRAM1 site 1, SRAM1 site 2, and SRAM3, respectively. Both review images are taken with pixel size of 20nm. From Figure 4a and 4c we can see that both SRAM1 and SRAM3 have 11 and half pairs of pass gate plugs, indicates the device densities in x-direction are the same. However, SRAM1 has 10 rows pass gate plugs while SRAM3 has 12 and half rows, indicates that SRAM3 is denser in y-direction than SRAM1. This can help us to explain the image difference around the pass gates. Because the two rows of N+/P-well plugs are closer in SRAM3, the dark rings around NMOS plugs merges that causes the oxide becomes dark around the pass gate plugs between the two rows of N+/P-well contact plugs. For SRAM1, because the distance between the two rows of N+/P-well plugs is larger, and the dark rings of each row are separated, and oxide around the pass gate plugs is relatively bright.

Figure 2. Optical image of SRAM 1 and SRAM 3.
